**EVALUATE TxDOT CHIP SEAL
BINDER PERFORMANCE
USING PAVEMENT MANAGEMENT
INFORMATION SYSTEM AND
FIELD MEASUREMENT DATA
SAN ANTONIO DISTRICT**

**Interim Research Report
Prepared by:**

**Douglas D. Gransberg, Ph.D., P.E., C.C.E.
and J.B. Carlisle.**

**University of Oklahoma
Norman, OK 73019**

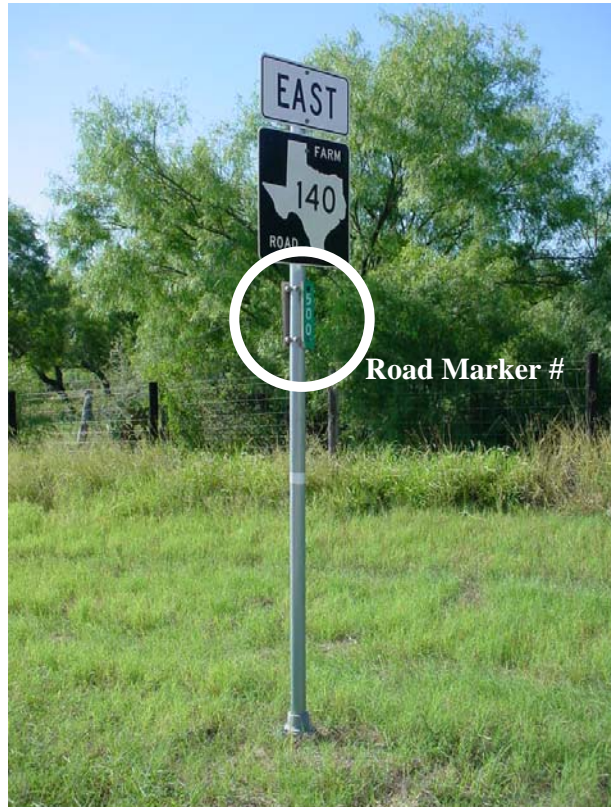
Figure 3: TxDOT Road Reference Marker

Before the testing could begin, the actual test roads and test sites had to be selected during the pre-condition stage of the project. Data collection roads were chosen based on regional location (San Antonio, Texas), chip seal type (six (6) emulsion roads, six (6) AC roads), and traffic count (all test roads have similar traffic volumes—approximately 100-600 vehicles per day). The first data collection occurred before new seals were placed to study the affect of previous conditions on the future character of the road. The Texas Department of Transportation (TxDOT) road markers (RM) provide fixed markers for locating purposes, and can be found every two (2) miles. Figure 3 is a typical TxDOT road reference marker. These markers allow the researchers to specifically return to each test site and also furnish a means of locational reference for the qualitative windshield condition surveys.

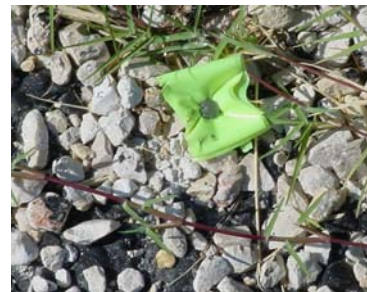
Figure 4: Green Flagging

Test sites were marked using green and pink surveyors flagging attached to a nail that was driven in the edge of the pavement at the location where the sand circle tests and corresponding digital images were taken. The pink flag was placed on the side of the road that the corresponding road reference marker was located and the green was placed on the opposite side of the road. As much as possible, these flags were located in line with a road reference marker. In those instances where this was not possible due to safety sight distance

requirements, they were placed in a measured correlation with some other off-road landmark such as a mailbox, a power pole, or a fence post. Figures 4 and 5 show the results of this marking system.

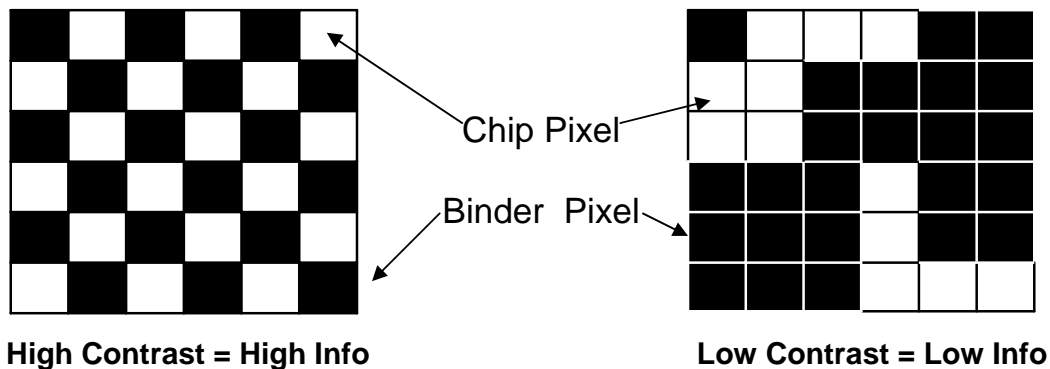
Figure 7: Information Content Measured as a Function of Contrast

a finite amount of information contained within its boundaries. This information can be measured by determining the relative change in luminance intensity between adjoining pixels in the image. This relative difference in luminance is called the spatial frequency. For example, if the luminance intensity of one pixel is high and the intensity of the next pixel is low, the difference between the pixels is a large number, and the two pixels would be said to have a high contrast and a correspondingly high spatial frequency. On the other hand, if two adjoining pixels have luminance intensities that are nearly equal, they would have low contrast and low spatial frequencies. High contrast occurs at the boundaries between two different objects in an image (Ellis, 1976). The relative visibility of an object against its background is a function of the amount of contrast (Cuvalci, et al, 1999). Figure 7 illustrates this concept graphically. Thus, in the chip seal image, the contrast is formed by the amount of light reflected off the exposed aggregate against the amount of light reflected off the background formed by the asphaltic binder (Christie, 1954). The Texas study found that TxDOT maintenance personnel could easily discern between a satisfactory chip seal surface and an unsatisfactory one by merely looking at it (Gransberg, et al, 1999). It was also obvious to the naked eye that the difference between chip seal performance success and failure had to do with the relationship between the aggregate and the surrounding binder. Therefore, it was postulated that one could measure the surface condition by correlating the information content of a digital image and the qualitative rating of the human expert. Such an objective metric would significantly facilitate the decision-making process of allocating funds among several chip seal candidate sections on a basis of a quantitative comparison rather than qualitative comparison.

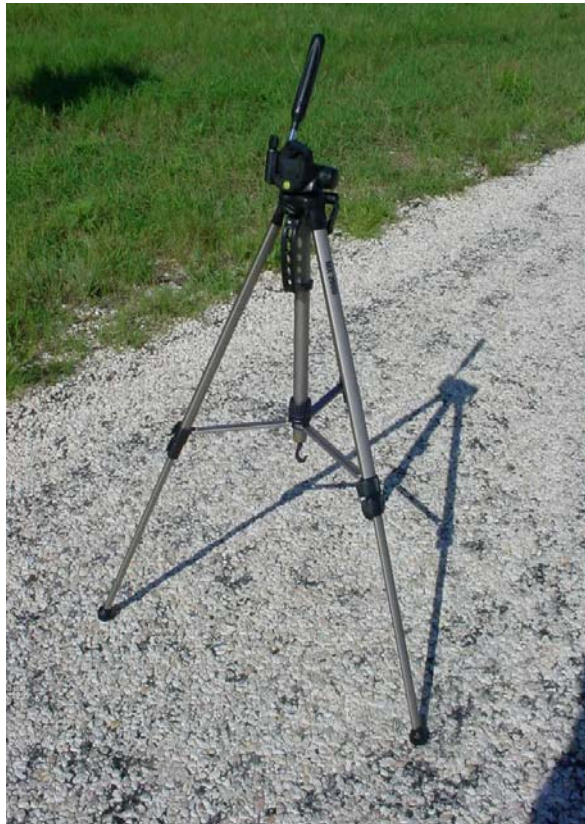
Figure 9: Tripod with legs properly adjusted

3. Label 3-½ floppy disk by the road name and current date before inserting it into the camera to record images.
4. Mark the Northbound or Westbound lane with a nail and green flagging (Figure 4).
5. Mark the Southbound or Eastbound lane with a nail and pink flagging (Figure 5).
6. There are two adjustments per leg on the camera tripod. Adjust the tripod so that one (1) adjustment per leg is fully extended (Figure 9). Position the camera with respect to the sun so that the back leg lines up exactly with its shadow.

7. Attach the digital camera to the tripod so that it sits at a ninety-degree angle.
8. Zoom the camera to its maximum.

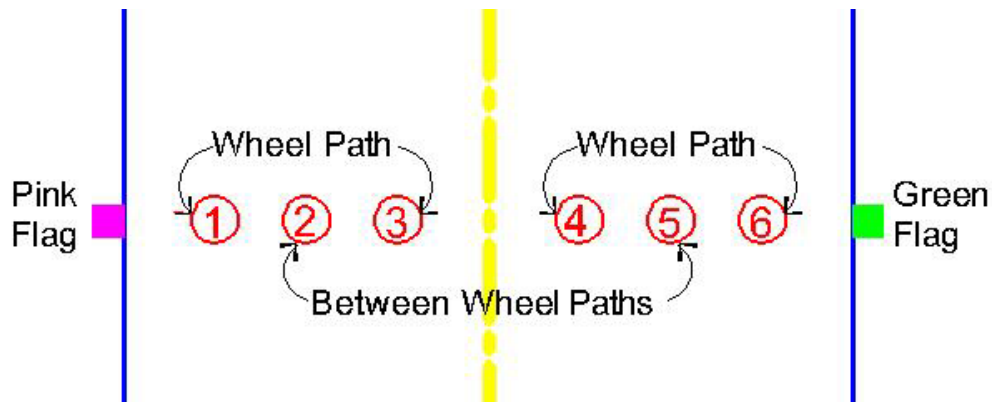
Figure 10: Image & Sand Circle Locations and Sequence relative to the Road

9. Starting at the wheel path nearest the pink flag, place the digital camera (attached to the tripod) ensuring that no shadows cross the area to be recorded.
10. Place a 1/4" washer, painted fluorescent orange for visibility, under the center point of the tripod on the road's surface to mark the location of the recorded image ensuring that the washer will not be recorded in the digital image.
11. Record the image.
12. Pick up the camera and tripod, and proceed to the location of the next image.
13. Working towards the green flag, the digital imaging process and washer placement is performed a total of 6 times. Progressively working from the pink flag to the green flag (see Figure 10 for the image sequence).

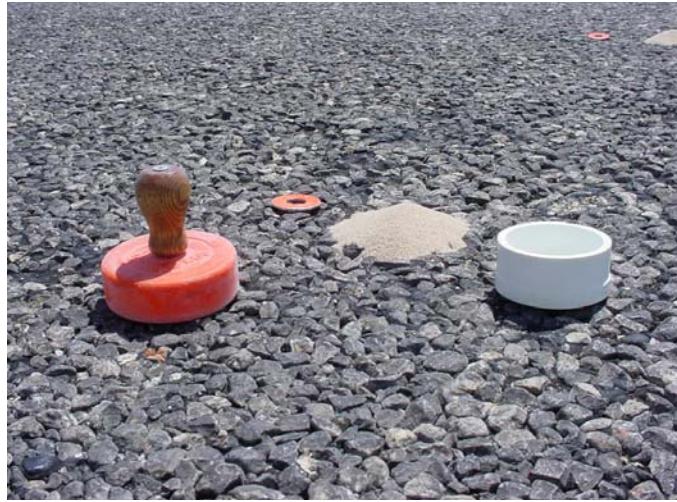
Figure 14: Testing Equipment (hockey puck, washer, sieved sand, PVC cup)

4. While the data recorder watches for traffic, tester shall perform the sand circle test at each of the locations designated by the six washers, while the other person records the data read out by the sand circle tester in the field data book.
5. Fill three PVC cups with sieved sand. The PVC cups are 2" PVC plugs precisely cut to hold 45 milliliters of sand. The sand was passed through a #40 sieve and retained on a #80 sieve to achieve near-uniform particle size. See 3.1.1 Texture Measurement in the Literature Review for additional information on the sand circle process. Figure 14 shows the test equipment.

6. Top off cup with straight edge (i.e. ruler) to ensure a precise quantity of sand.
7. Setting your body up to block any wind that may be in evidence on the day of the test, carefully dump one cup of sand at the location where the first image was taken.
8. Using the spreading tool (hockey puck pictured in Figure 15), spread the sand using a circular motion until the voids in the pavement have been filled and the sand is even with the top of the pavement. The circle of sand should be as uniform as possible.

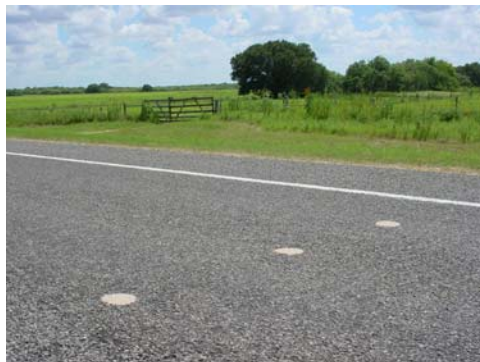
Figure 16: Southbound Lane Sand Circles on Highway 119

9. Use a clear plastic metric ruler to measure the longest and shortest diameters of the sand circle—record the average of the two, in millimeters, as the circle's diameter.
10. Perform the next two sand circles to complete one traffic lane, refill the three cups with sand, and proceed to perform the test on the next lane.
11. Record all data, and travel to the next road site. Figure 16 shows a typical test site after the sand circle tests have been completed.

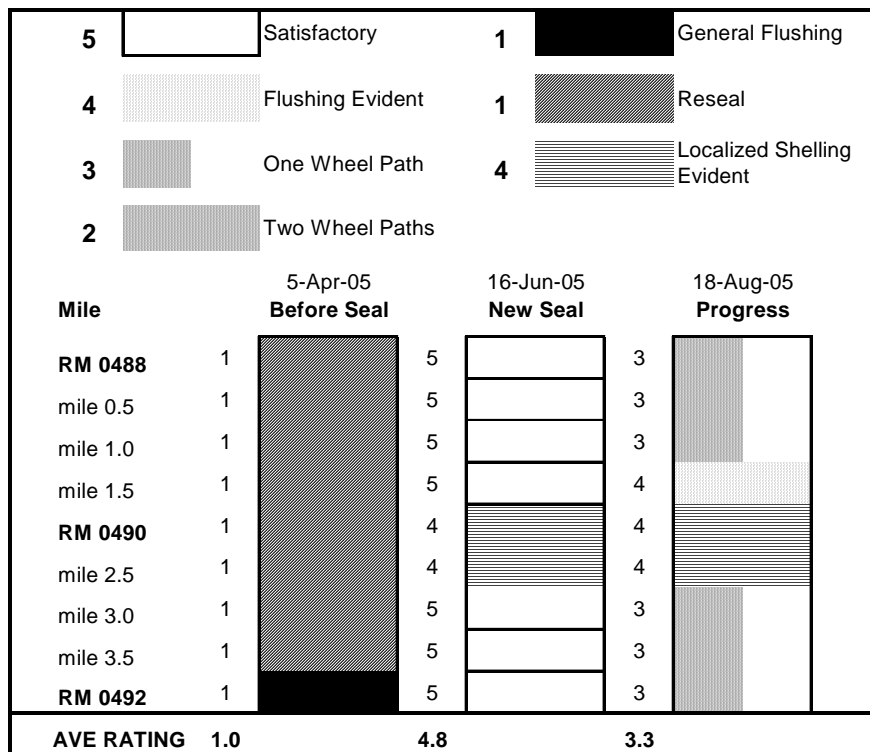
Figure 19: FM 1470 Windshield Analysis

Looking at Figure 18, one can see that roads with both binder types were improved to nearly perfect condition. After the first progress sample (two months), it appeared that the EM roads had started to deteriorate faster than the AC roads. However, when looking back into the preseal data (Figure 19), it was found that FM 1470 had apparently failed due to flushing at some point in its recent past and had a reseal applied. This would tend to make it have a higher binder content than a road with a 5 to 7 year old seal in it. The August 18th survey showed that the road was starting to flush prematurely and that can be attributed to the reseal.

When FM 1470 was removed from the sample, the average change in the EM roads was the same as the AC roads. Given the inherent difficulties discussed above with the inherent visual differences between the “black rock-black binder” AC roads and the “white rock-black binder” EM roads, the research team will focus not on the discreet average condition number but rather the differences between the changes in the qualitative condition numbers over time.

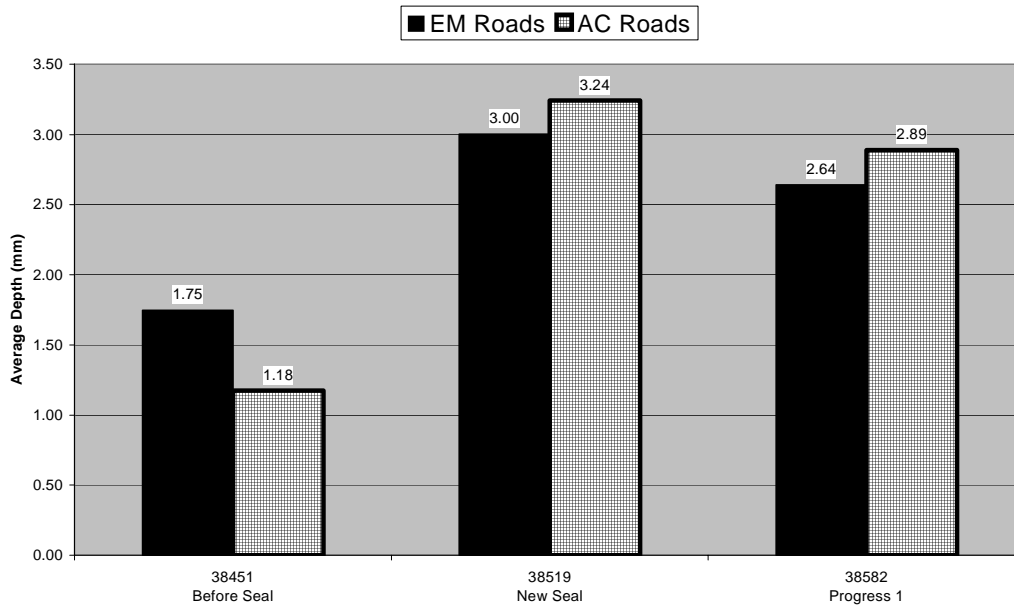
Figure 19: Overall Comparison of Texture Depth Change in the Wheel Paths to Date.

Figure 19 shows the overall results for the average texture comparisons in the wheel paths of the EM and AC roads (the greater the depth, the higher the texture rating). Figure 20 shows the results between the wheel paths and Figure 21 is the average texture depth calculated using a mathematical average of the data shown in the two previous figures. The texture depth in the wheel paths is probably the measurement of greatest interest. Transit New Zealand states that traffic can be used to enhance aggregate embedment by “traffic control to direct slowly moving vehicles over the fresh seal and to move the traffic stream gradually across the entire width of the seal to aid in compaction...” (TNZ, 2005). Thus, they depend on the additional embedment that is achieved by traffic on a new seal. In Texas, this will only happen in the wheel paths as policy is to open a newly sealed road to traffic as soon as feasible.

EM vs. AC Roads: Average Texture Depth - Wheel Paths

When looking at the three figures, the reader must remember that the texture depth shortly after a new seal is primarily a function of the size of the aggregate and the amount of rolling that was completed during chip seal construction. Therefore, the discrete measurements of texture between the two binders are not nearly as informative as the change in texture over time. In Figure 19, one can see that both the AC and the EM roads lost approximately 0.35 millimeters of texture between the new seal reading and the first progress measurement. Between the wheel paths, Figure 20 shows that the EM roads lost only 0.2 millimeters whereas the AC roads changed by 0.58 millimeters. Thus, the AC roads apparently either gained embedment between the wheel paths because the construction rolling was inadequate or more likely, the embedment due to traffic was greater because the substrate was softer. As the AC roads had more flushing prior to the seal, this second explanation seems more logical. Finally, when the average change in texture depth is considered in Figure 21, The EM roads lost 0.36 millimeters of depth while the AC roads lost 0.49 millimeters.

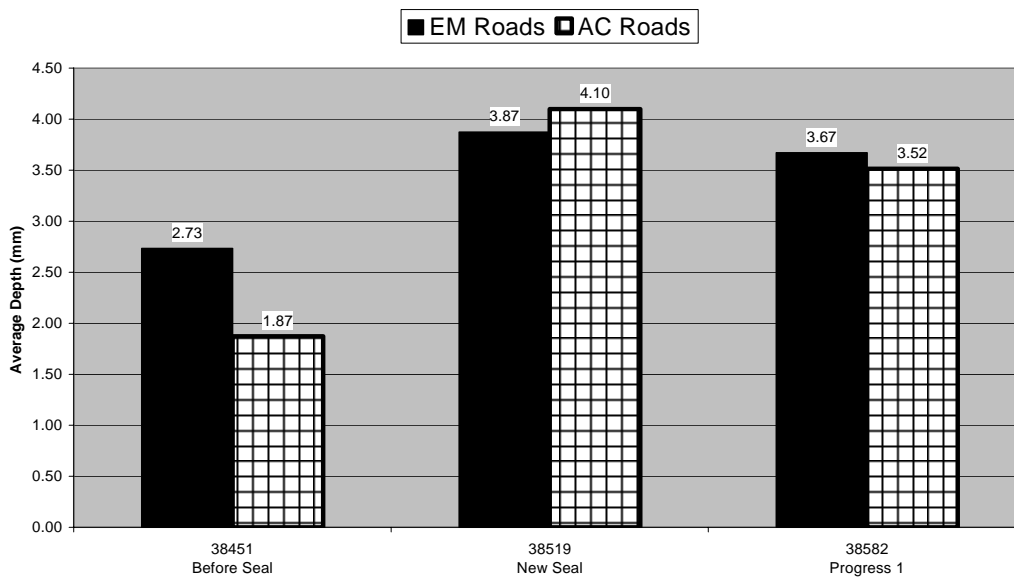
Figure 20: Overall Comparison of Texture Depth Change Between the Wheel Paths to Date.

EM vs. AC Roads: Average Texture Depth - Between Wheel Paths
